## ALEXANDRIA

### KOM EL-DIKKA PRESERVATION WORK 1996/97

**Wojciech Kołataj**

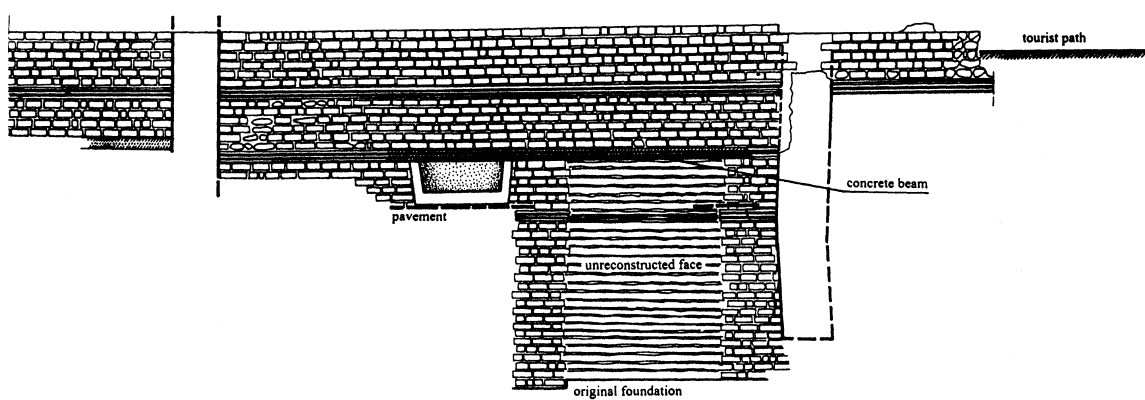
Work was completed on the final landscaping of the southern end of the eastern wall of the corridor. A large part of the face of the upper wall was completed and the top of the wall was insulated. Test trenches dug along the southern end of the wall (western face) that separated the cistern from street R4 revealed that the structure was preserved to a depth of c. 5 m above sea level. A partial reconstruction of the western face of this wall was begun in accordance with the original work program, resulting in a total of 9 m<sup>2</sup> being reconstructed over the season (fig. 1).

Fig. 1. South end of the wall (western face) separating the cisterns from street R4.  
Drawing W. Kolqataj.

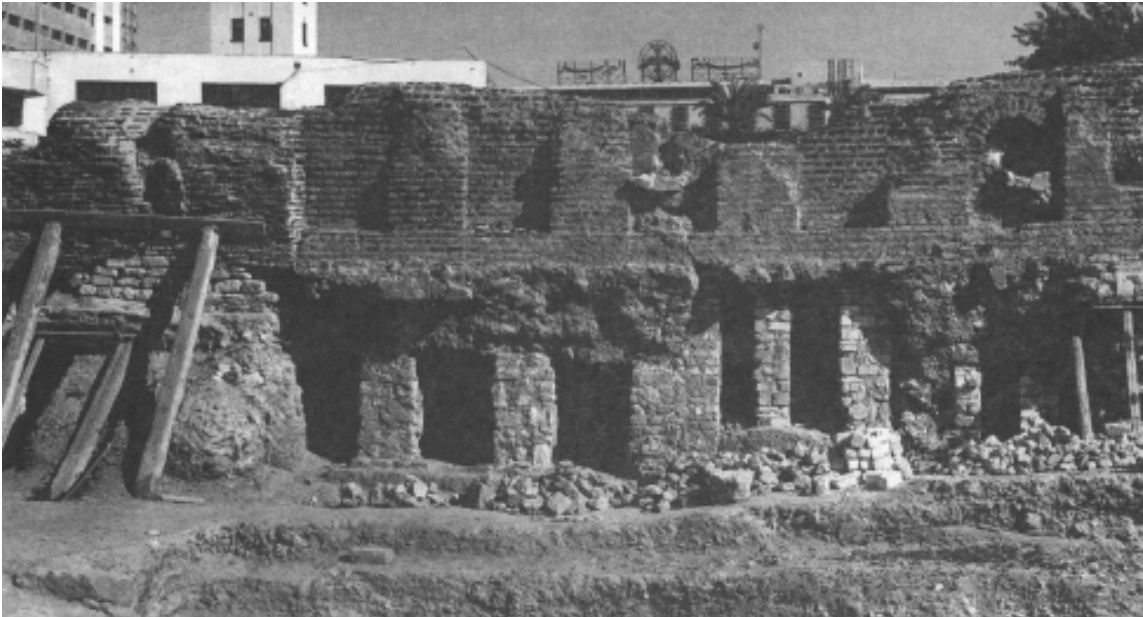
*Fig. 2. Northern facade of the cistern.  
Photo W. Jerke.*

Clearing of the northern facade of the cistern in 1995/96 had revealed a dangerous overhanging of the upper parts of this elevation. Almost the entire length of this facade (c. 50 m<sup>2</sup>) was cleared this year, providing visible proof of the fact that practically the entire cistern complex stands on top of

a number of extensive voids created by the caving in of the structures that had lain underneath. The work was extremely dangerous, requiring the most endangered fragments to be cleared and protected on a step-by-step basis. Since protection in this case does not concern a historic building (cistern) and in any case it is only a structural reinforcement of fragments threatening to collapse, the supporting walls and pillars, of which a total of 17 m<sup>2</sup> was constructed, were made using a semi-cement mortar (fig. 2).

Investigations of the northern cistern facade proved that it had been robbed out in the Middle Ages in a section 20 m long and 2.50 m or more high. The reconstruction of this wall facing will be completed next year.

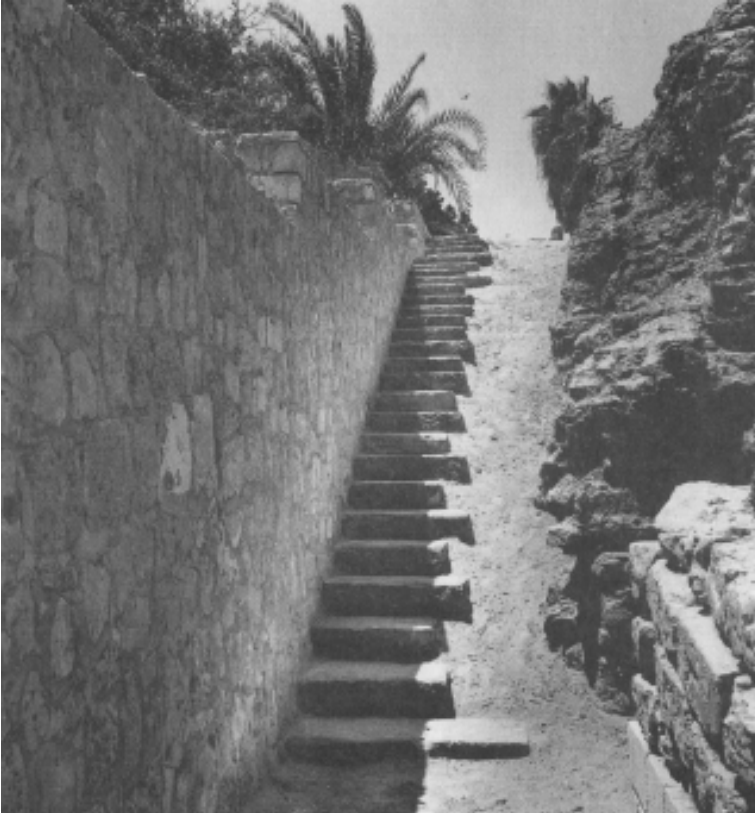
*Fig. 3. New stairs and revetment wall at the southern edge of the cistern.  
Photo W. Jerke.*

With respect to the *Zona Monumentale* landscaping project, it should be noted that 2,000 m<sup>3</sup> of excavated soil were removed from the area of the bath's *frigidarium*, as well as modern deposits from the surface layers in the area between the theater and the bath complex. Besides, a total of 25 m of pavement and steps was laid along the southern perimeter of the site, using basalt slabs and basalt and granite cobblestones recovered from the debris accumulated in the modern layers (fig. 3).
